Structure Behaviour Analysis and Detection of Errors Made at the Design Stage

To cite this article: V Alekhin *et al* 2020 *IOP Conf. Ser.: Mater. Sci. Eng.* **753** 032063

In this work we present the survey of a Vostochnyi roofed market building (figure 1) in Chelyabinsk. After the reconstruction of this building it became necessary to conduct a survey and the analysis of the behavior of its load-bearing structures. These works were carried-out by the specialists of Institute of Civil Engineering and Architecture of Urals Federal University (CEIA UrFU) and designers of TECHCON Ltd. Several errors made during the reconstruction were revealed by the abovementioned survey.

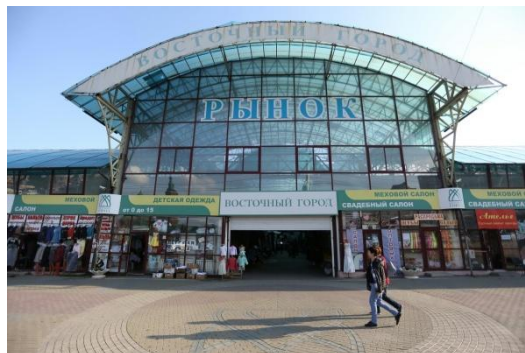
Figure 1. Structural module, Vostochnyi roofed market.

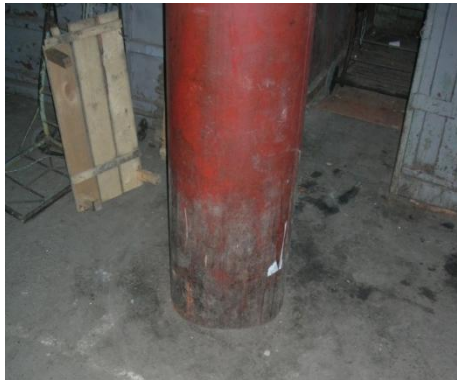
During the construction of the building, structural modules "Kislovodsk" with load-bearing capacity of 300 kgf/m² were replaced with four 320 kgf/m² modules (modules No. 1 to 4) and two 400 kgf/m² modules (No. 5 and 6). The structural modules are supported by tubular steel columns which are rigidly connected to the foundations (figure 3).

Figure 3. Column.

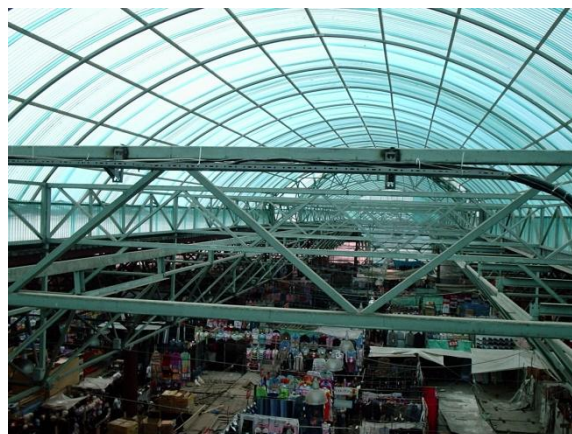
Initially, spaces between the modules were covered with separate light arched structures. During the use of the building, arch skylights with 9 meter span have been installed in these spaces (figure 4). Two independent structures were created as a result. Structural modules 1 – 4 have their edges connected by arch skylights forming a "cross" and are connected in the center with a "valley" structure which is also an arch skylight. The latter have caused an excessive loading condition resulting in deformation of individual structural components.

A geodetic survey of the positions of the structural module bottom chord points and the arch skylights showed that the skylight structures resting on the bottom chord of the structural modules causes a significant influence.

Figure 4. Arched structures of skylights resting on the bottom chords of structural modules.
